# WETLAND ASSESSMENT REPORT

**For the proposed Mining  
Right Application on the  
farm Winterveldt 293 KT  
within Modikwa Platinum  
Mine in Burgersfort,  
Limpopo Province.**

—  
**Date:** May 2024

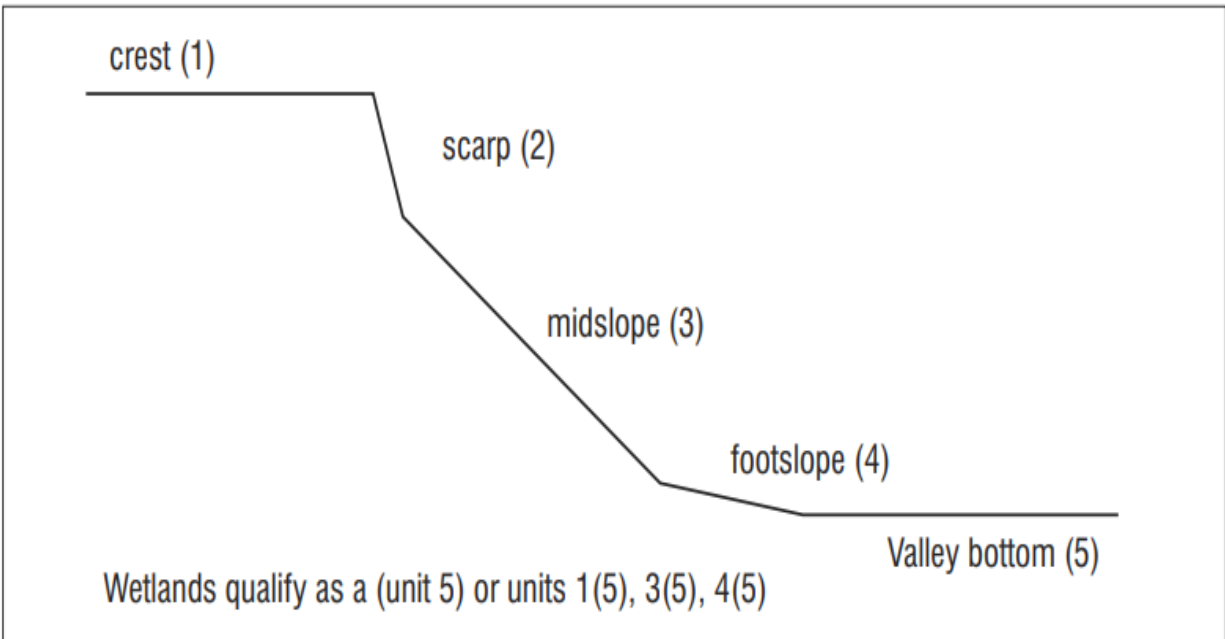
**Figure 10: terrain Units** (Forestry, 2005)

A wetland usually qualifies as a valley bottom unit (see **Figure 11**) as defined by (McVicar et al , 1977). However, Unit 5 may also occur as a depression on a crest (1), midslope (3), or foot slope (4), as depicted in Figure below, and can then be described as 1(5), 3(5), or 4(5) respectively.

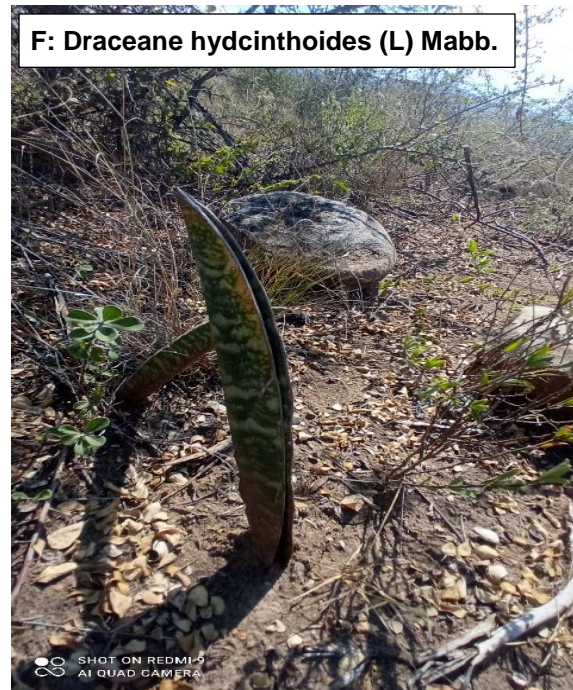
**Figure 12: Some of the vegetation species that were pronominally found onsite (Segope Consulting, 2024)**

The vegetation types that have been observed within the area of the proposed site are Sekhukhune Plains Bushveld. The total of plant species that were identified during the site visit was 34 of these species 27 fell into the category of least concern, while 3 were not evaluated as they are naturalized exotic species. One protected species was identified as well as one which is considered threatened and none of the species observed were hydrophytes (Ecology Study by Segope Consulting , 2024).

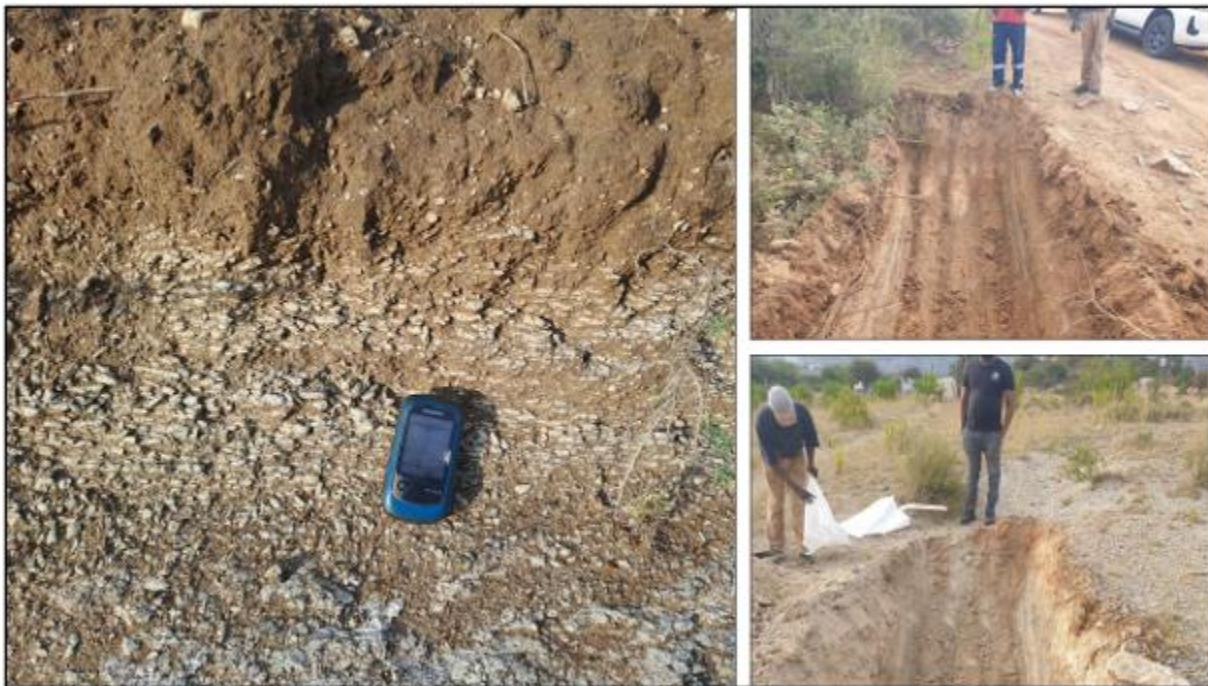
**Figure 13: The responsive (shallow) hydropedological soil type associated with the study area (Enviro-Solum Consulting, 2024).**

During the site assessments, the soil was assessed using the auger to check the soil composition, color, number, size, and chroma of mottles as well as wetness to confirm the zone of the wetlands. Some parts of the project area consisted of the Mispfa/Glenrosa and Coega soil forms are shallow and characterized by an orthic horizon underlain by lithic or hard rock material and hard carbonate horizons, respectively. The rocky outcrops are associated with the mountainous areas with miscellaneous soils, refer to **Figure 14** (Hydropedology Study by Enviro-Solum Consulting, 2024)

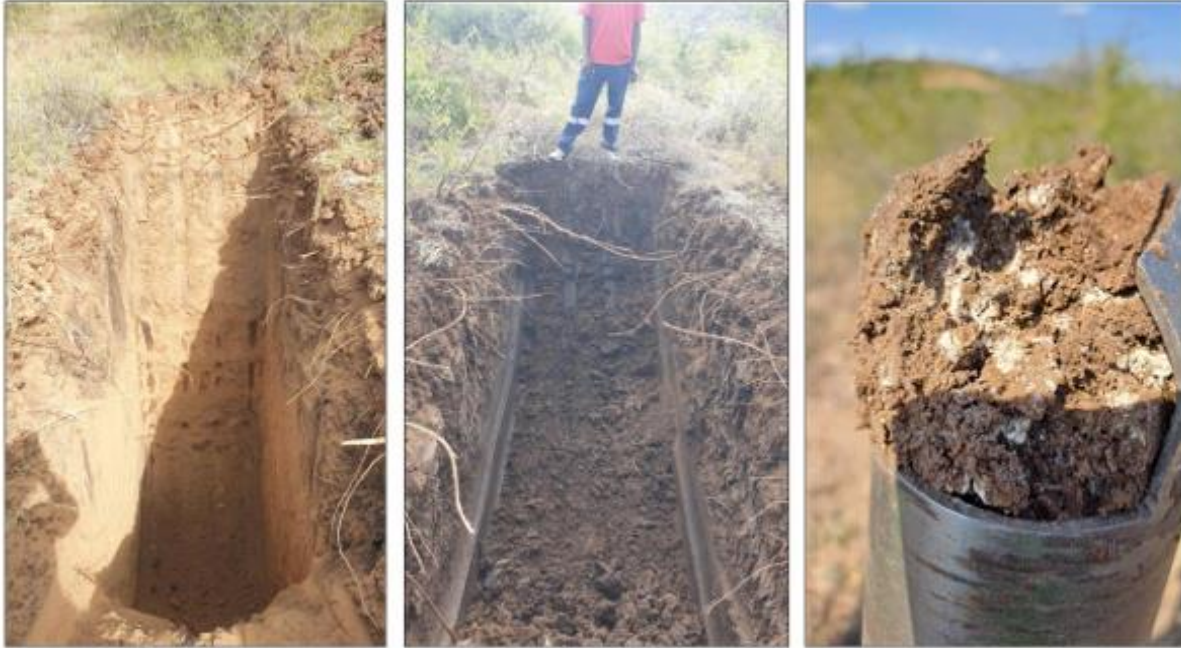
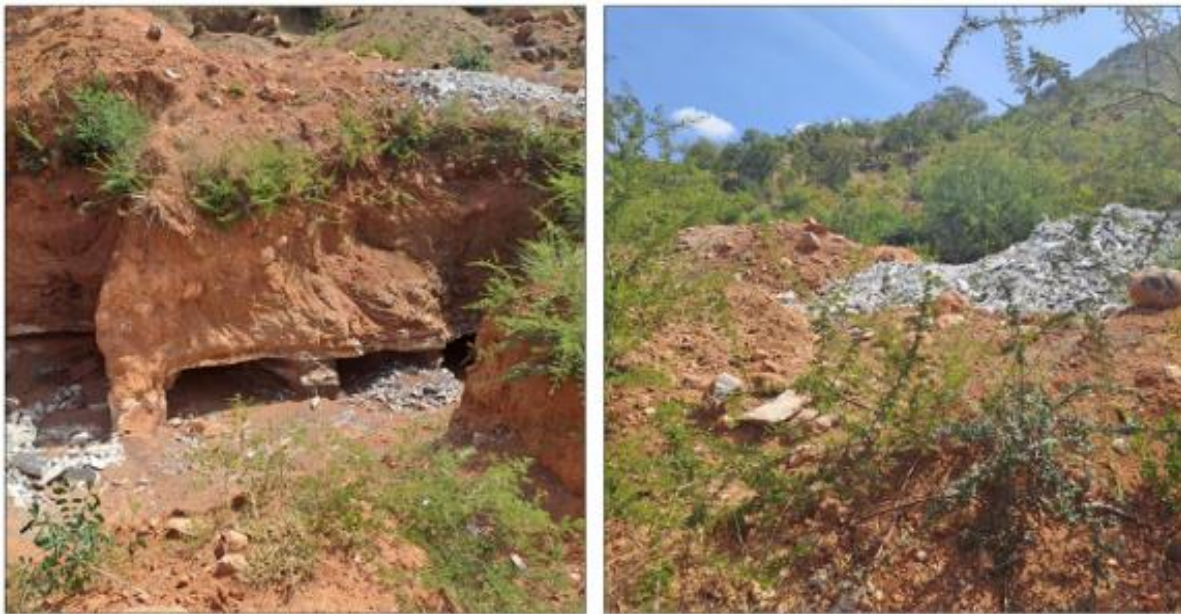
### A: Bonheim/Abbotspoort Soils

### B: Witbank Soils

**Figure 14: The soil types observed within the proposed mining right boundary (Enviro-Solum Consulting, 2024)**

The majority of the study area is covered with Bonheim/Abbotspoort and Witbank soils (**Figure 15**). Bonheim/Abbotspoort soils are deep, dark-colored, clayey, and structured with pedocutanic and neocutanic characteristics. The highly intensive rainfall events of short duration and the clayey nature of these soils promote surface runoff and discourage infiltration, sometimes leading to erosion gullies which ultimately act as preferential flow path drainage lines. In the event of no internal drainage impediments, these soils may allow water percolation downward through the profile to weather rock and lime-rich subsoil horizons. Witbank soils are disturbed anthrosols that have not undergone intentional transportation. The disturbance is such that the diagnostic horizons are no longer arranged in any discernible order or recognizable herozization. As in the case of the anthrosols identified on site, they have undergone significant disturbance (Hydropedology Study by Enviro-Solum Consulting, 2024)

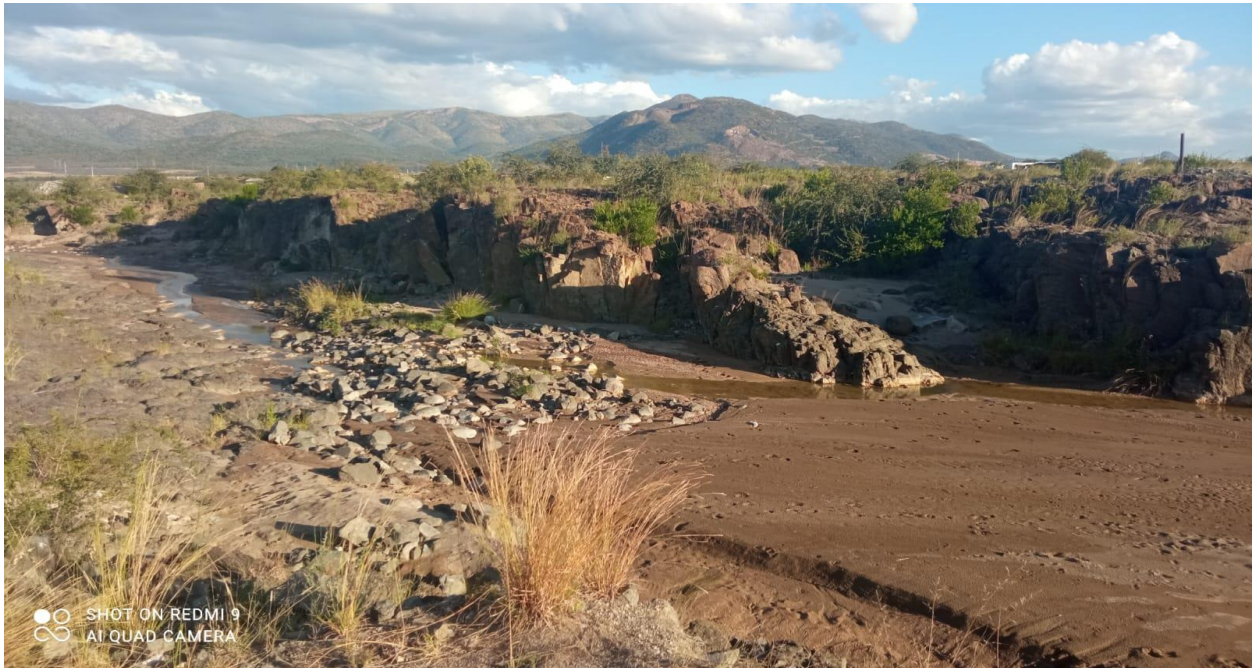
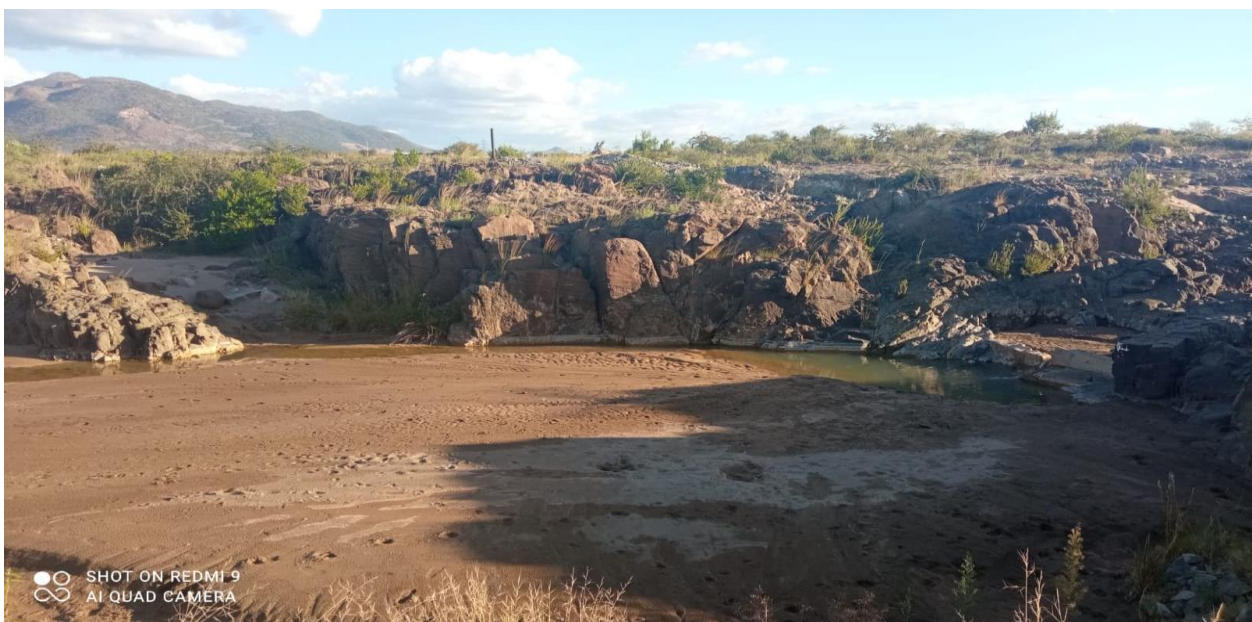
**Figure 15: Tubatsane River observed in proximity to the project area (Segope Consulting, 2024)**

The hydrology is the primary driving force behind all wetlands is water. However, due to its dynamic nature varying daily, seasonally, and annually, it is not a very useful parameter for accurately identifying the outer boundary of a wetland. Although for the proposed project area water was also used as one of the indicators for delineation as there is a perennial river observed onsite approximately 50 m away from the project's boundary (**Figure 16**).
