WETLAND ASSESSMENT REPORT VERIFICATION REPORT

**For the proposed
Processing Plant of
Universal Chrome Minerals
(Pty) Ltd under Madibeng
Local Municipality in
Northwest Province.**

—
WULA REF: WU41699

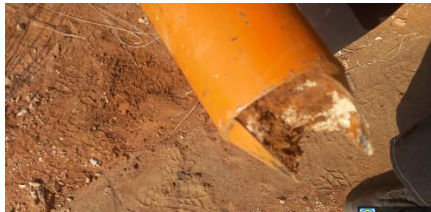
Description	Site pictures and equipment
The soil auger was used to extract the cores to a depth of 50cm	Auger

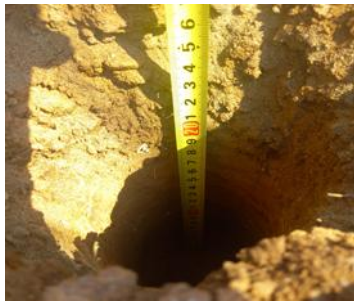
The depth of the hole is measured using the measuring tape after identifying the different layers of soil.	Measuring Tape

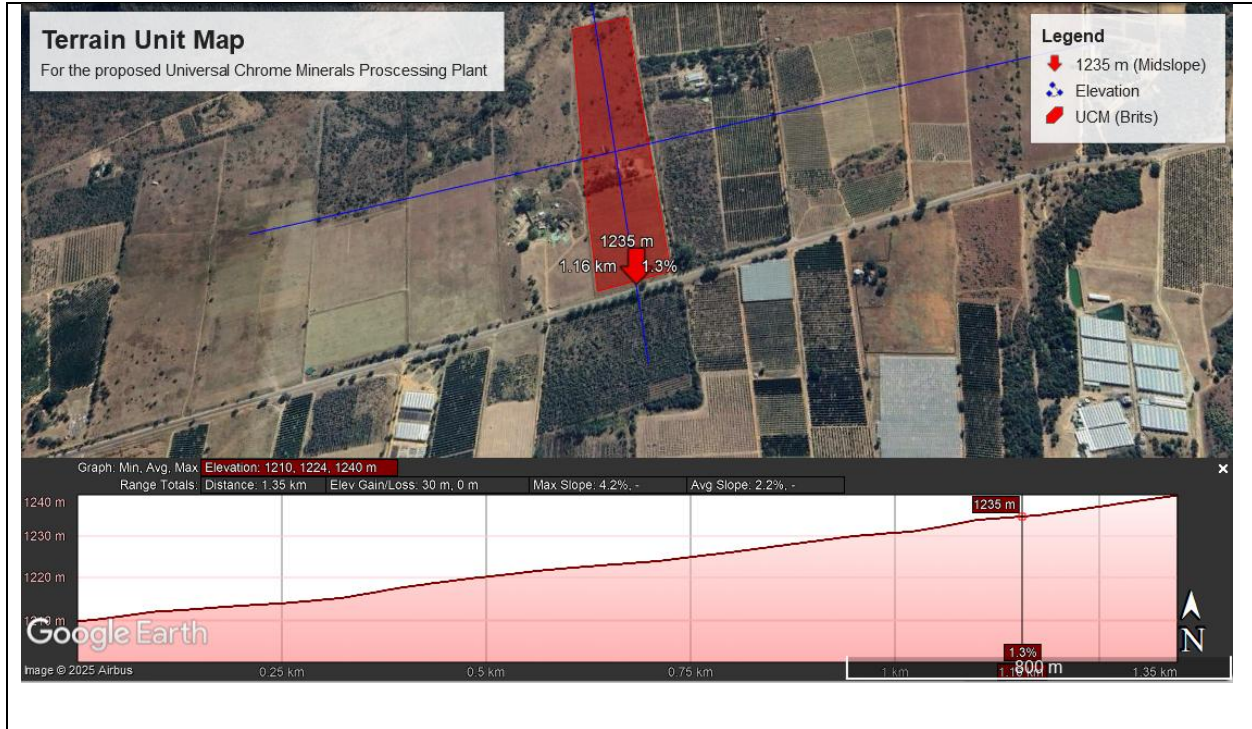
Figure 11: Terrain Unit Map for the proposed mining project (Segope Consulting, 2025)

The project area consists of two terrain units, namely midslope and valley bottom, and as shown under section 3.1.1 above, the mentioned terrain unit alone does not qualify for the wetland to be formed. It should be noted that the terrain unit indicator is an important practical index for identifying those parts of the landscape where wetlands are likely to occur.

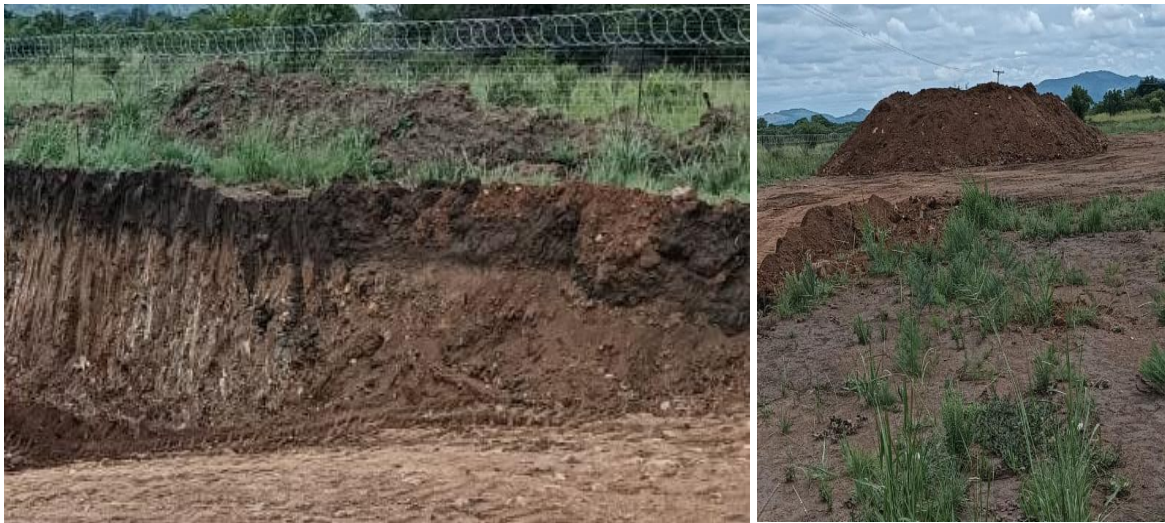
Figure 12: View of soil forms within the study area (Segope Consulting, 2025).

The soil in the project area falls within the land type Bc8, which is typically characterized by shallow to moderately deep soils often underlain by hard rock or weathered material. The dominant potential soil forms

in this area include Mispah, Hutton, Avalon, and Kroonstad, which are commonly associated with diverse soil properties and land uses.

These soil forms are part of a plinthic catena, indicating a sequence of soils that occur along a slope and are influenced by drainage patterns and water movement. The presence of plinthic horizons—often hardened layers rich in iron and aluminium—suggests seasonal waterlogging and redox processes, which may influence land use capability and vegetation patterns.

The area also features red apedal soils, which are typically well-drained and structureless (lacking in distinct soil aggregates), making them moderately suitable for various agricultural and development activities depending on the depth and fertility. These red soils are indicative of oxidized conditions, often found on well-drained slopes or plateaus.
